Lincoln Experimental Satellite-5
(LES-5)
Transponder Performance in Orbit

W. W. Ward B. E. Nichols

1 November 1968

TECHNICAL NOTE 1968-18

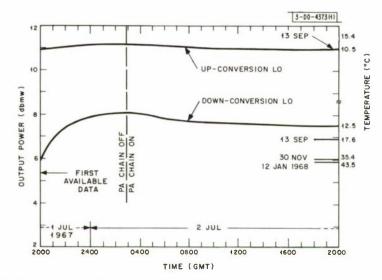
Fig. 13. Transponder local oscillators, turn-on and heating effects.

For some time before launch it was known that the temperature sensitivity of LO 1 was abnormally large compared to the test-point-measured power output of LO 2. Some instabilities within the LO's were climinated at Cape Kennedy by rebuilding their output sections. There remained a turn-on effect, lasting several minutes, in which the telemetered output of LO 1 came to its steady-state value from an initial, slightly higher, value. This effect has been observed in orbit during turn-on after eclipse. It was established at Cape Kennedy that this effect was not in the telemetry system.

It is now apparent that these fixes did not solve all the problems. LO 2 has shown very little change in performance (excluding celipse phenomena) since injection into orbit. Its output power level continues in fractional-db agreement with that measured at Cape Kennedy. LO 1, however, started out at an output power level agreeing approximately with the Cape Kennedy results.* Its output power soon rose almost 2 db above that level as LES-5 cooled down during the ~7-hour interval between injection into orbit and turn-on of the PA chain (Section III-A). This effect persisted through the months following launch, the output of LO 2 gradually falling as the temperature of the spacecraft increased with the approach of the winter solstice (Fig. 13). It is apparent that something else in the transponder associated with LO 1 is temperature-sensitive, and that the output of LO 1 reflects this sensitivity. By late November, the LO 1 power level had fallen back to that observed in the Cape Kennedy tests. By mid-January it had fallen a little below that level.

The frequency shift of LO 1, first noted 24 January 1968, was accompanied by another slight decrease in output power. Subsequent data show output power increasing as LO 1 cooled in its passage through the spring eclipses toward the summer solstice. At its minimum, LO 1 output power remained several db above the estimated level at which deficiency would be perceptible to transponder users. Both LO's possess extra performance margins. The apparent change in output-power level could conceivably be an effect produced by some shortcoming in the measuring circuit.

It cannot be said conclusively what happened to LO 1. In working with capacitors of the type used in the LES-5 LO 1 circuits for development of the LES-6 transponder, it has been noted that the values of some capacitors have changed abruptly. This effect is being investigated more thoroughly.

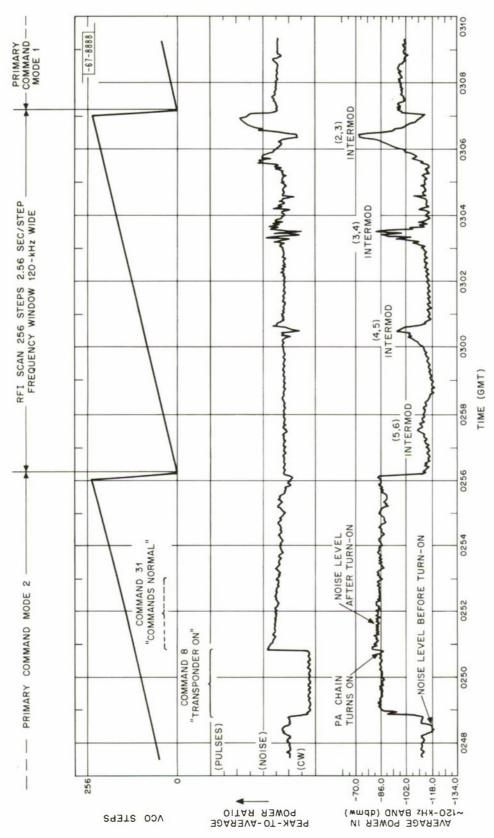
Fig. 34. RFI data.

The events of these stirring minutes are graphically presented in Fig. 34 that shows the principal outputs of the RFI instrument. Briefly, the RFI instrument reports by telemetry the power levels of primary command signals received by LES-5 and provides a spectrum analysis of received signals in the 253 to 283 MHz region. Timing is normal (single rate). The uniform progress of the command timing ramp (or stepper) through its 256 steps (one-fourth are telemetered out via CL-2) in about 11 minutes is shown in the top frames. The bottom frames show the average-power reading (RFI-1). In the ramp segment at left, the system is in primary command mode 2. The noise level is represented by the dip at about 02:48:30. The command "Transponder ON" (Section III-A) shows up strongly in the average-power data as well as in the peak-to-average-power-ratio data (RFI-2) in the central frames. The PA chain turns on at the

At the end of the primary-command-mode interval, the RFI instrument began its scan across a portion of the military UHF band. The average-power channel, confirmed by the peak-to-average-power-ratio channel, shows the successive appearance of these intermodulation product terms (Table 5). For most of this RFI scan (excluding sensitivity-test intervals), the down-link signal consists of the beacon signal (very narrowband) plus a 100-kHz-wide noise signal with spectral tails. The intermodulation products are broadened by the corresponding (N-1) factors. The next primary-command-mode interval (mode 1, partially shown in Fig. 34) has a lower level of intermodulation-product effect in the average power channel. This indicates the intermodulation products had been getting smaller during the 16 minutes since turn-on of the PA chain. The conclusion is strengthened by noting that the center frequency of primary command channel 1 (255.0 MHz) is closer to the center frequency of the (2, 3) intermodulation product (253.85 MHz) than is the center frequency of primary command channel 2 (255.3 MHz).

After the main telemetry transmitter was turned off (not shown in Fig. 34, see Section III-A and Appendix C) these intermodulation products ceased to exist. The full sensitivity of the transponder receiver, measurable directly or by the X5 telemetered test point (Section IV-G) was regained. RFI-scan data became representative of the electromagnetic environment that was under surveillance.*

There is no indication that degradation of the solar-cell array will bring about permanent shutdown of the LES-5 PA chain within the immediate future. Regarding intermodulation products, the fifth-order (2, 3) term had decreased by at least 26 db over that observed on launch night (Fig. 34), the only previous occasion when both transmitters were turned ON in orbit. This measurement would have been more informative had it not been for the 17-db sensitivity degradation caused by failure in RF amplifier No. 1 (Appendix B). The fifth-order (and higher) intermodulation products may be down by much more than this amount. Perhaps some beneficent effect of the space environment (cold-welding of finger-stock electrical contacts, for example) is responsible for this blessing.

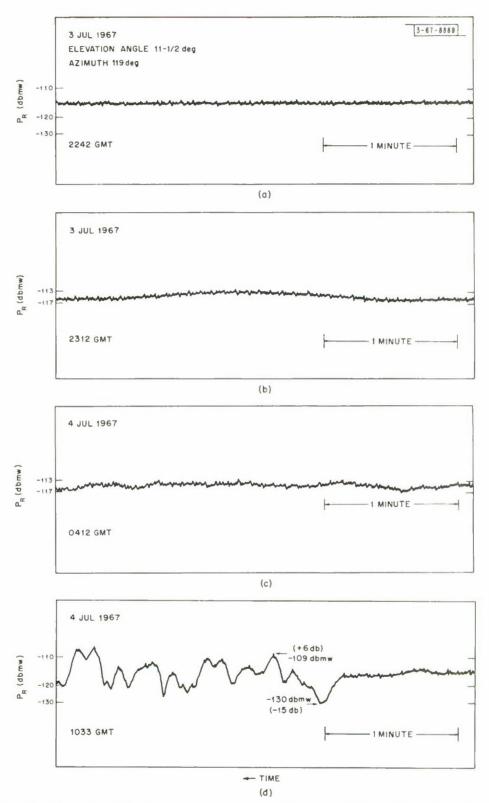
Table 7 contains a summary of fading greater than 3 db observed at clevation angles greater than 5° through August 1967. Character of the fading during the period is indicated by samples of strip-chart recordings (Figs. 35 and 36). The first fading observed after August occurred 12 December 1967 (Fig. 37).

Fig. 35. Example of fading via the beacon: (a) steady signals, (b) slight fading, (c) more jittering fading and (d) severe fading.

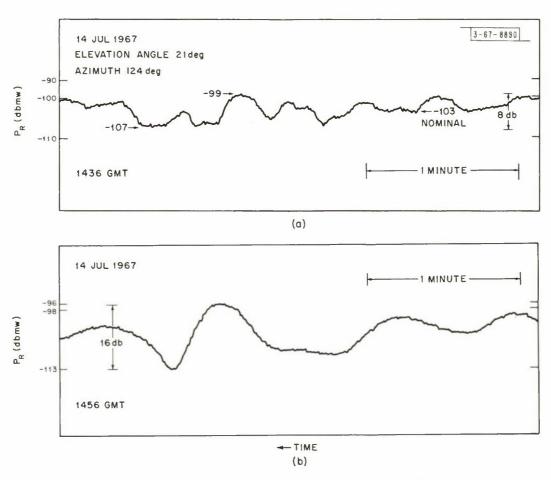
Fig. 36. Examples of fading via the transponder tone.

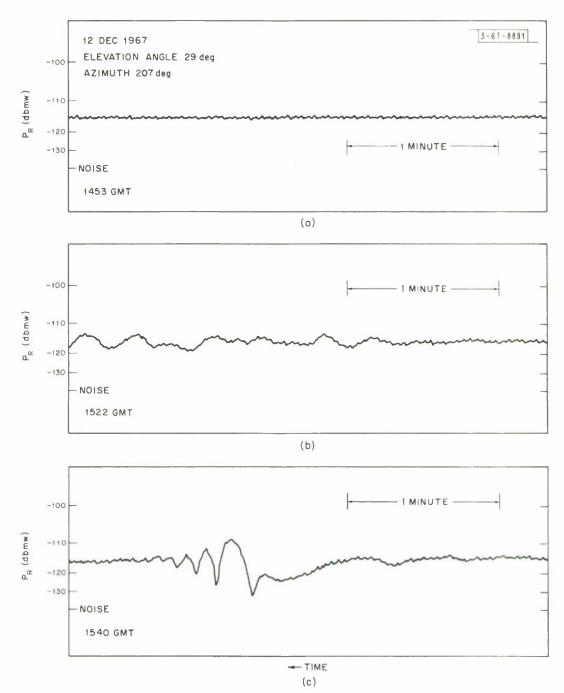
Fig. 37. Examples of fading via the beacon: (a) steady signals, (b) slight fading and (c) severe fading.

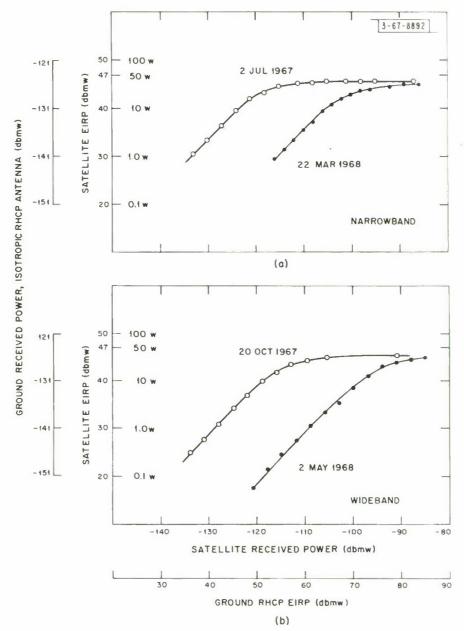
Fig. 38. Transfer curves: (a) narrowband, (b) wideband.

Analysis of the circuit failure was conducted with the aid of a back-up RF amplifier essentially identical with that flown. It was found that a current decrease of this magnitude was consistent with an open circuit somewhere in the components and connections associated with the emitter junction of the input transistor (a germanium device). The results of these bench tests

are in good agreement with the measured degradation in transponder sensitivity (about 17 db) and the measured reduction in strong-signal RF gain at 255 MHz (about 21 db, as observed through the RFI instrument).

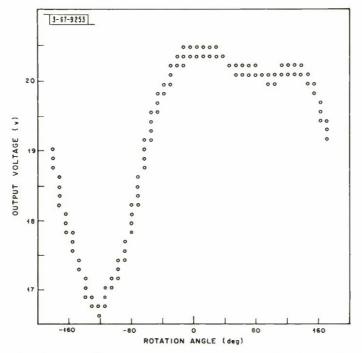
Fig. 39. Output voltage from power converter No. 4 as a function of LES-5 rotation. Data taken 17 July 1968.

Figure 39 shows the output voltage of power converter No. 4. For the 180° of satellite rotation in which the failed-connection group of cells is in shadow, the solar-bus voltage is at its full level (degraded slightly from what was expected, however). As the failed-connection group

of cells comes into sunlight, the solar-bus power decreases, the solar-bus voltage drops, and the power converter goes further out of regulation — its output voltage falls sharply. The solar-bus voltage recovers as the failed-connection group of cells passes out of sunlight.
